Debris/Ice/TPS Assessment And Integrated Photographic Analysis For Shuttle Mission STS-50

DEBRIS/ICE/TPS ASSESSMENT
AND
PHOTOGRAPHIC ANALYSIS
OF
SHUTTLE MISSION STS-50

June 25, 1992

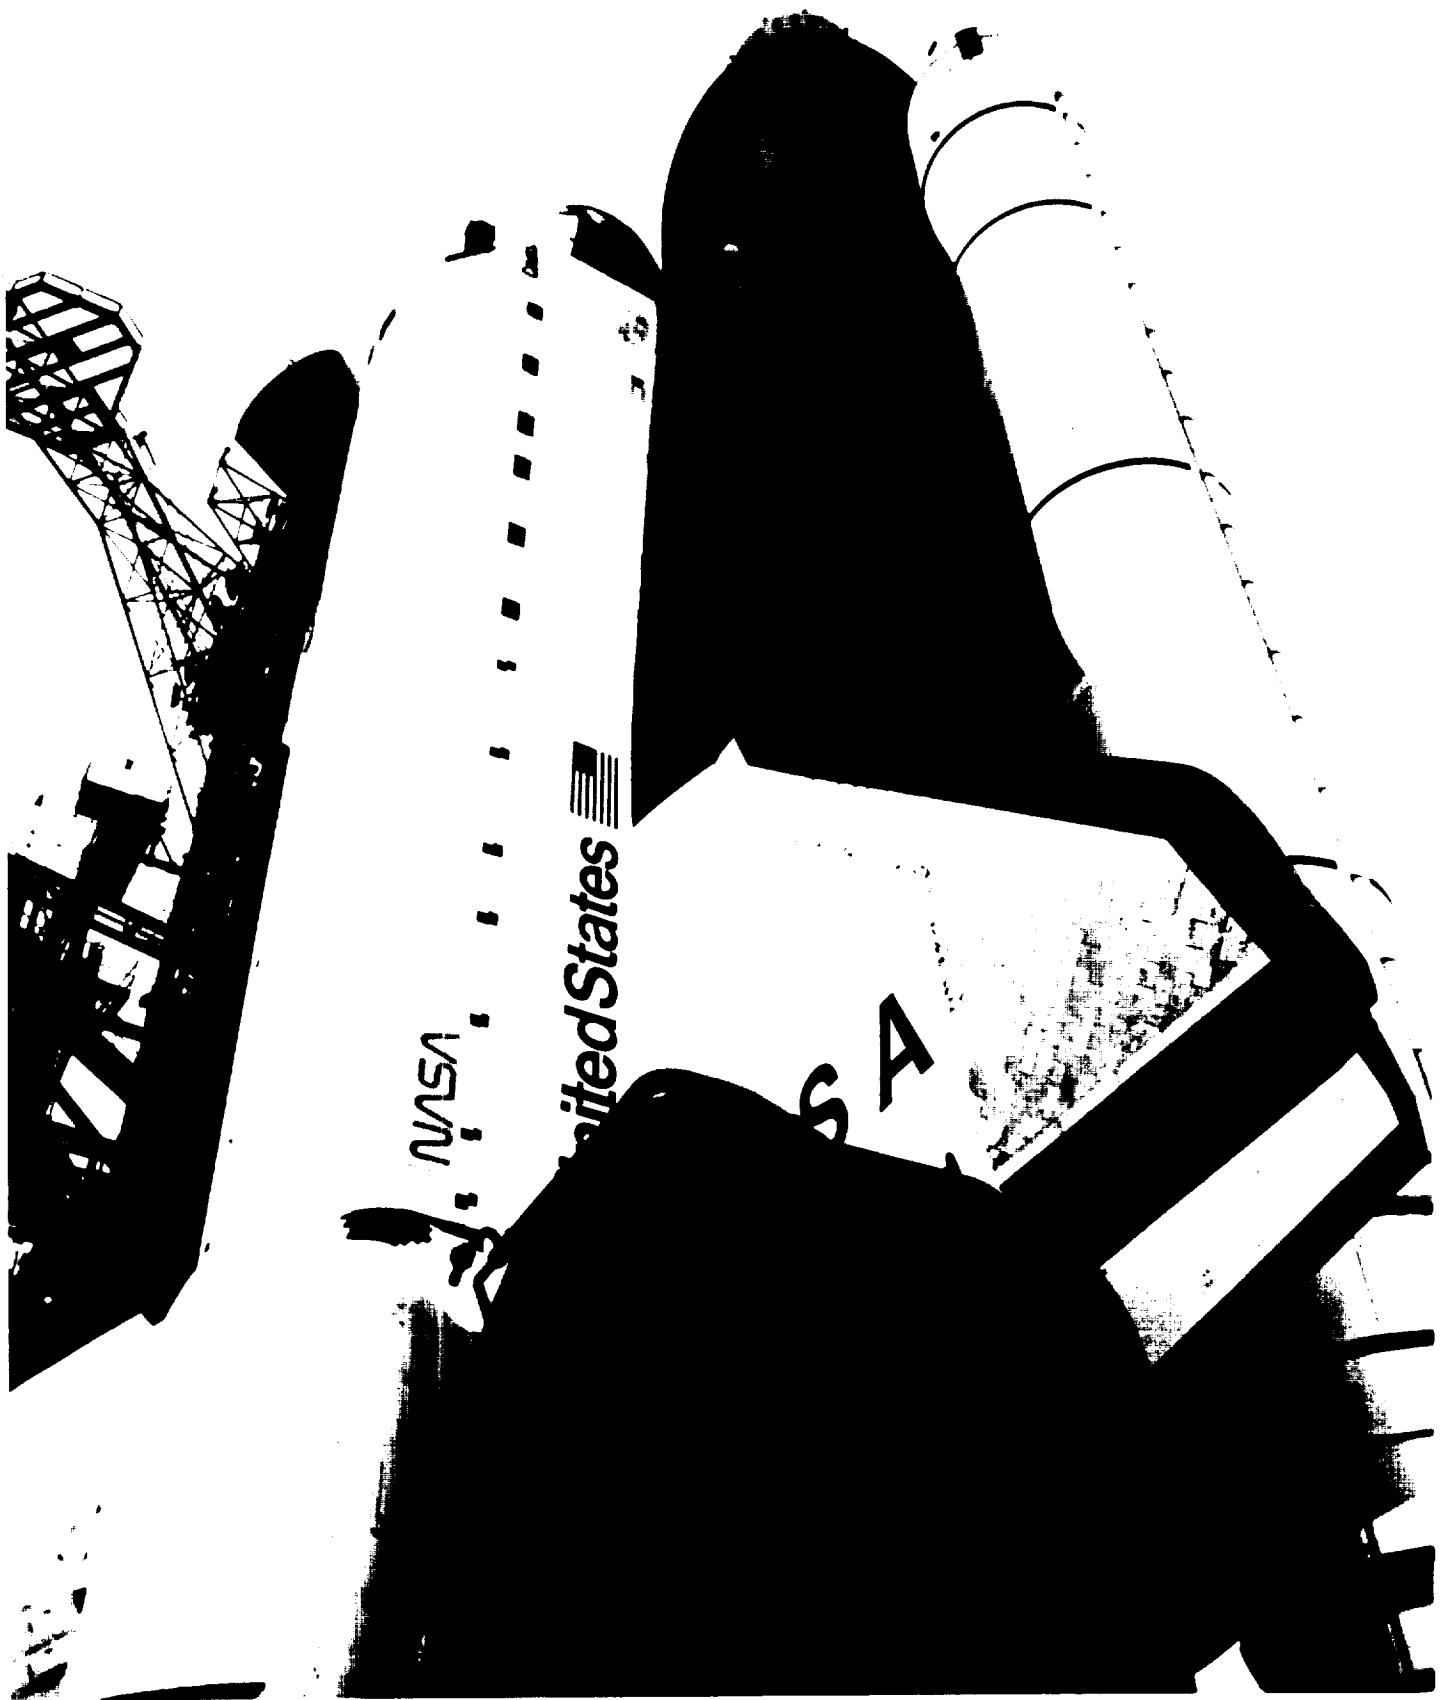
Very light condensate, but no ice or frost accumulations, were present on the ET LO2 and LH2 tank TPS acreage.

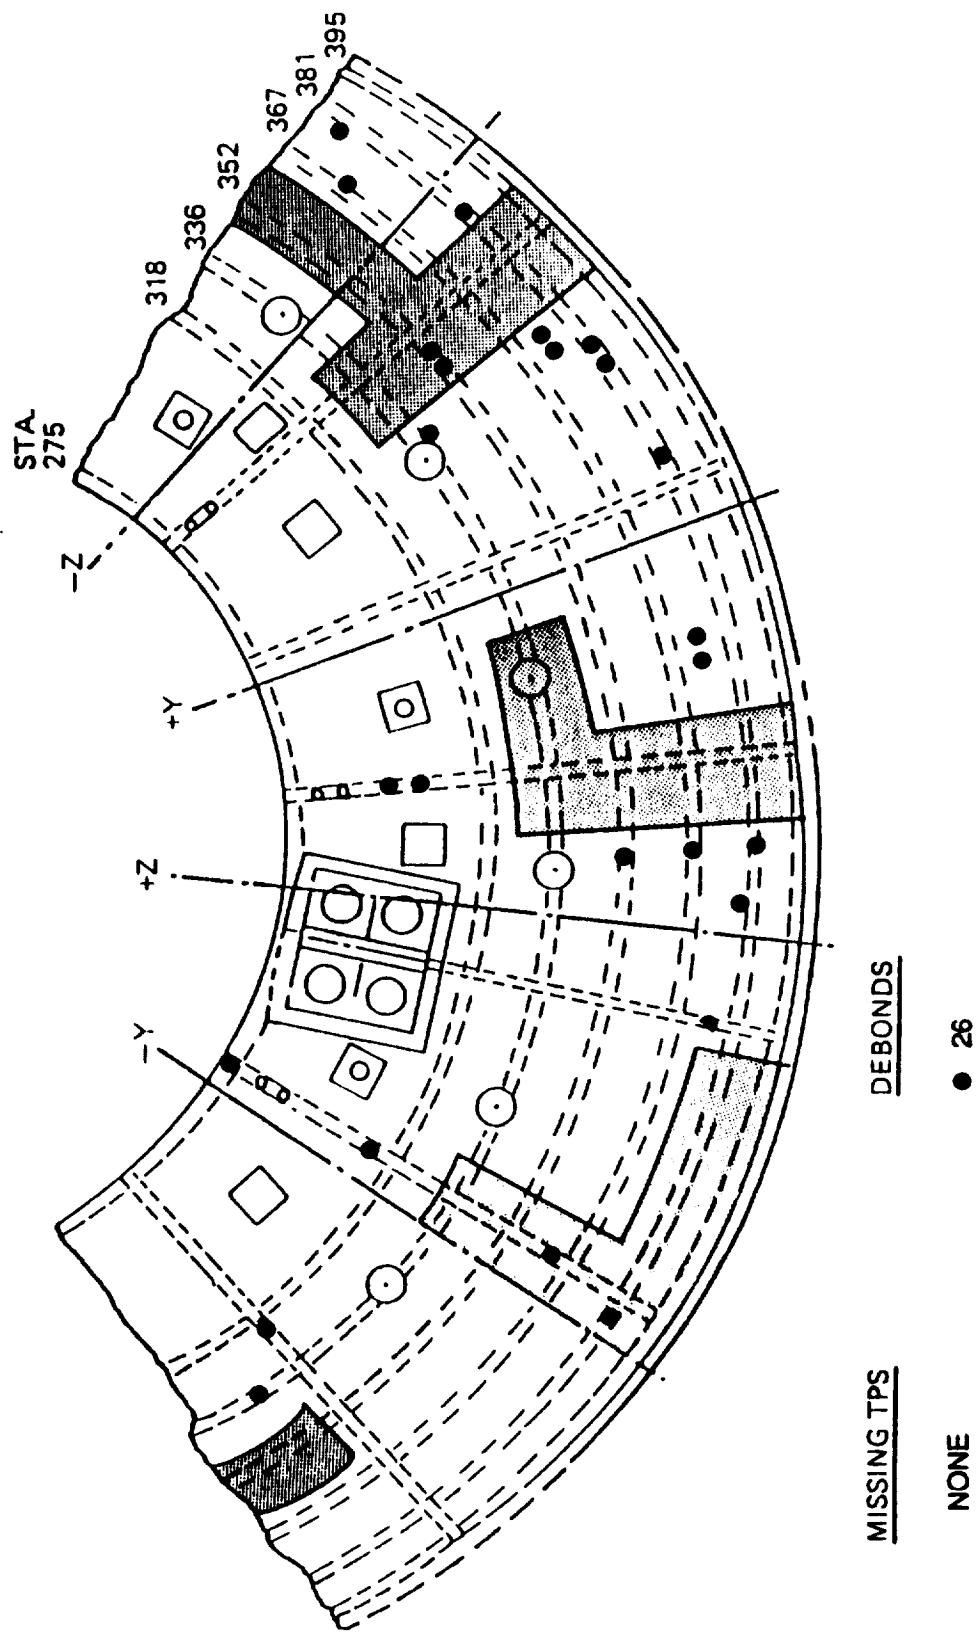
Figure 4. RIGHT SRB FRUSTUM

The RH frustum was missing no TPS but had 26 MSA-2 debonds over fasteners (Figure 4). Minor localized blistering of the Hypalon paint had occurred along the 395 ring. All BSM aero heatshield covers were locked in the fully opened position.

The RH frustum was missing no TPS but had 26 MSA-2 debonds over fasteners. Minor blistering of the Hypalon paint had occurred along the 395 ring. The BSM aero heat shield covers were locked in the fully opened position.

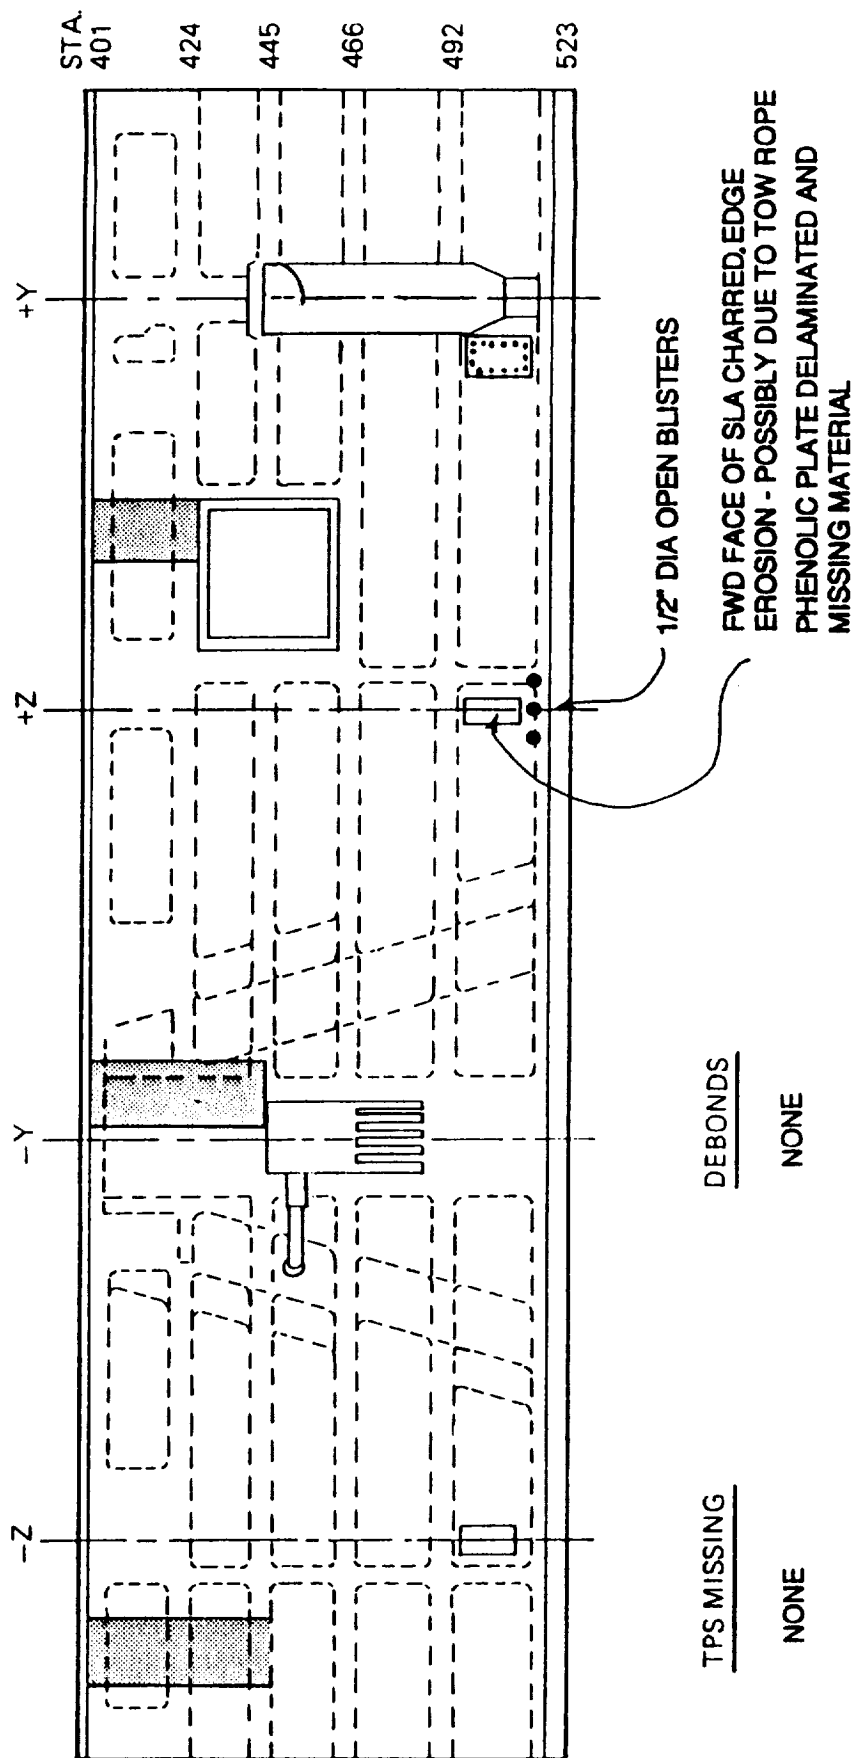
Figure 5. RIGHT SRB FWD SKIRT

The RH forward skirt exhibited no debonds or missing TPS (Figure 5). The -Z RSS antenna was undamaged. Ablator on the +Z RSS antenna cover was significantly eroded, which may have been caused by contact with the tow rope. The top two layers on the phenolic base plate were missing/delaminated. Minor blistering of the Hypalon paint occurred on the systems tunnel cover. No pins were missing from the frustum severance ring. The forward separation bolt and electrical cables appeared to have separated cleanly.

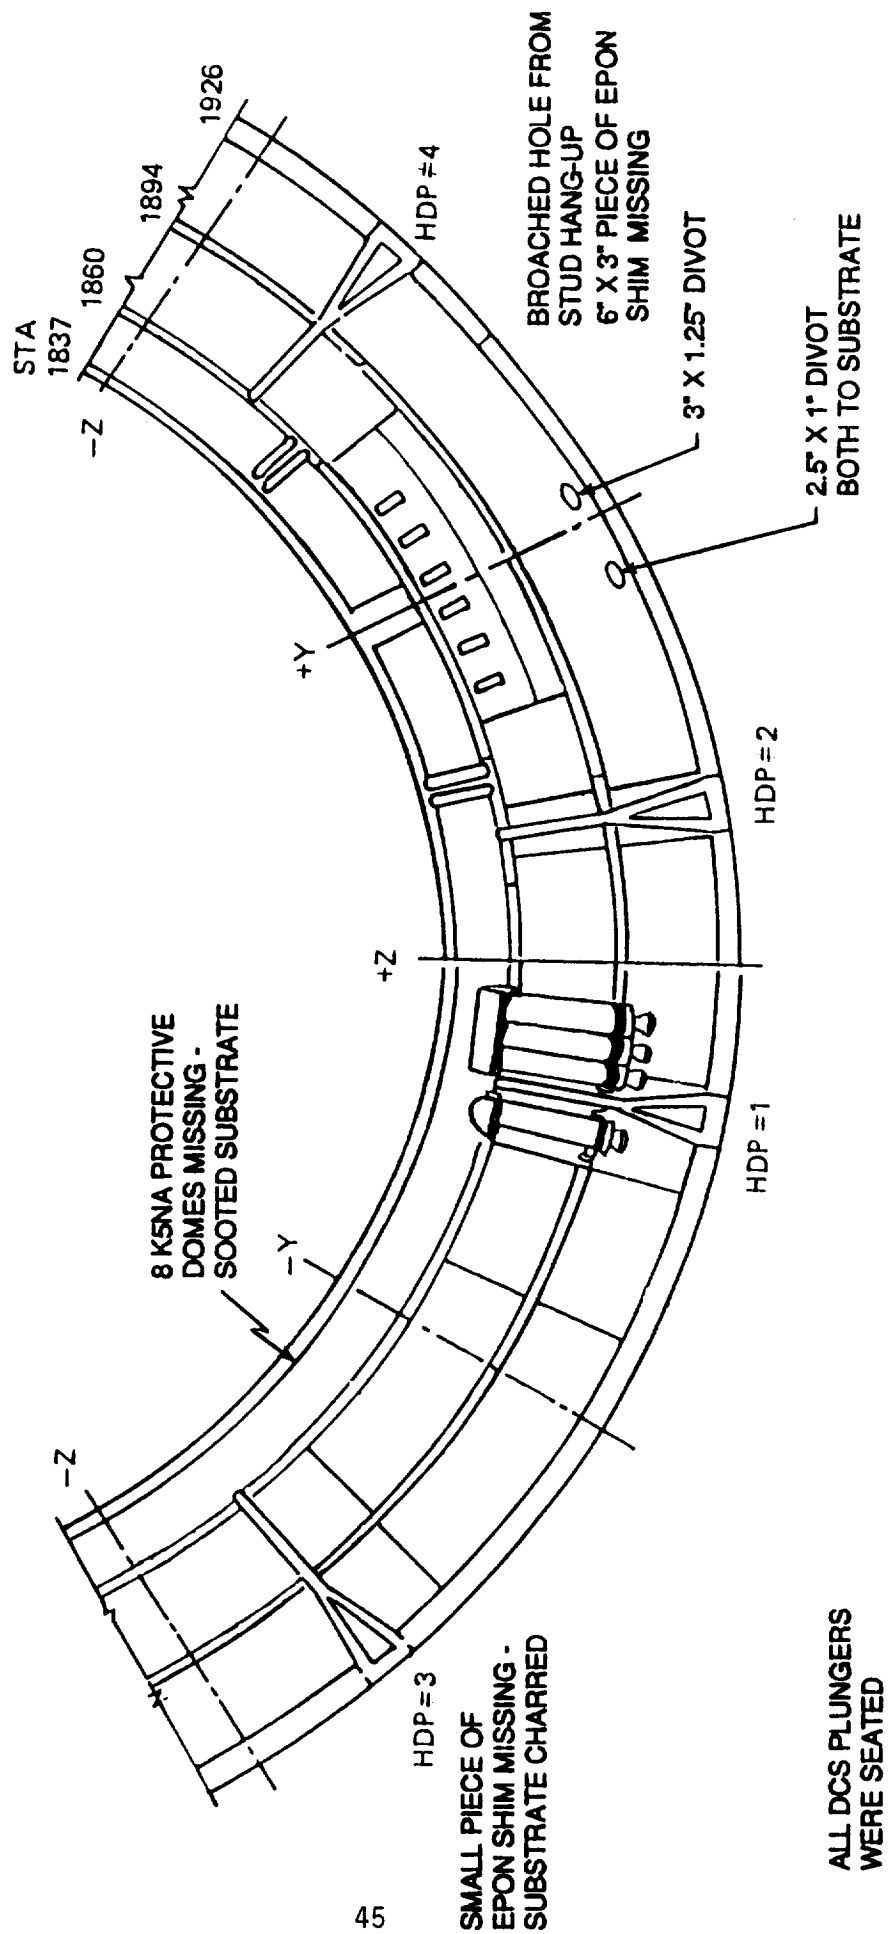
Figure 6. **RIGHT SRB AFT SKIRT EXTERIOR TPS**

The phenolic material on the kick ring had delaminated. Eight K5NA protective domes were lost from bolt heads on the aft side of the kick ring prior to water impact (sooted substrate). The aft skirt acreage TPS generally was in good condition. Two TPS divots (2.5"x1", 3"x1.25") were present on the +Y axis of the aft skirt near the aft ring (XB-1926). Since sooting/charring was evident on the edges of the divots, the surrounding material was removed for further analysis. K5NA was missing from all aft BSM nozzles (Figure 6).

The HDP #4 stud hole was broached due to a stud hang-up at lift off as observed in the launch films. A 6"x3" piece of the EPON shim material had been pulled off by the stud. A small piece of the HDP #3 EPON shim was missing prior to water impact (sooted/charred substrate). All Debris Containment System (DCS) plungers were seated properly. This was the eighth flight utilizing the optimized link.

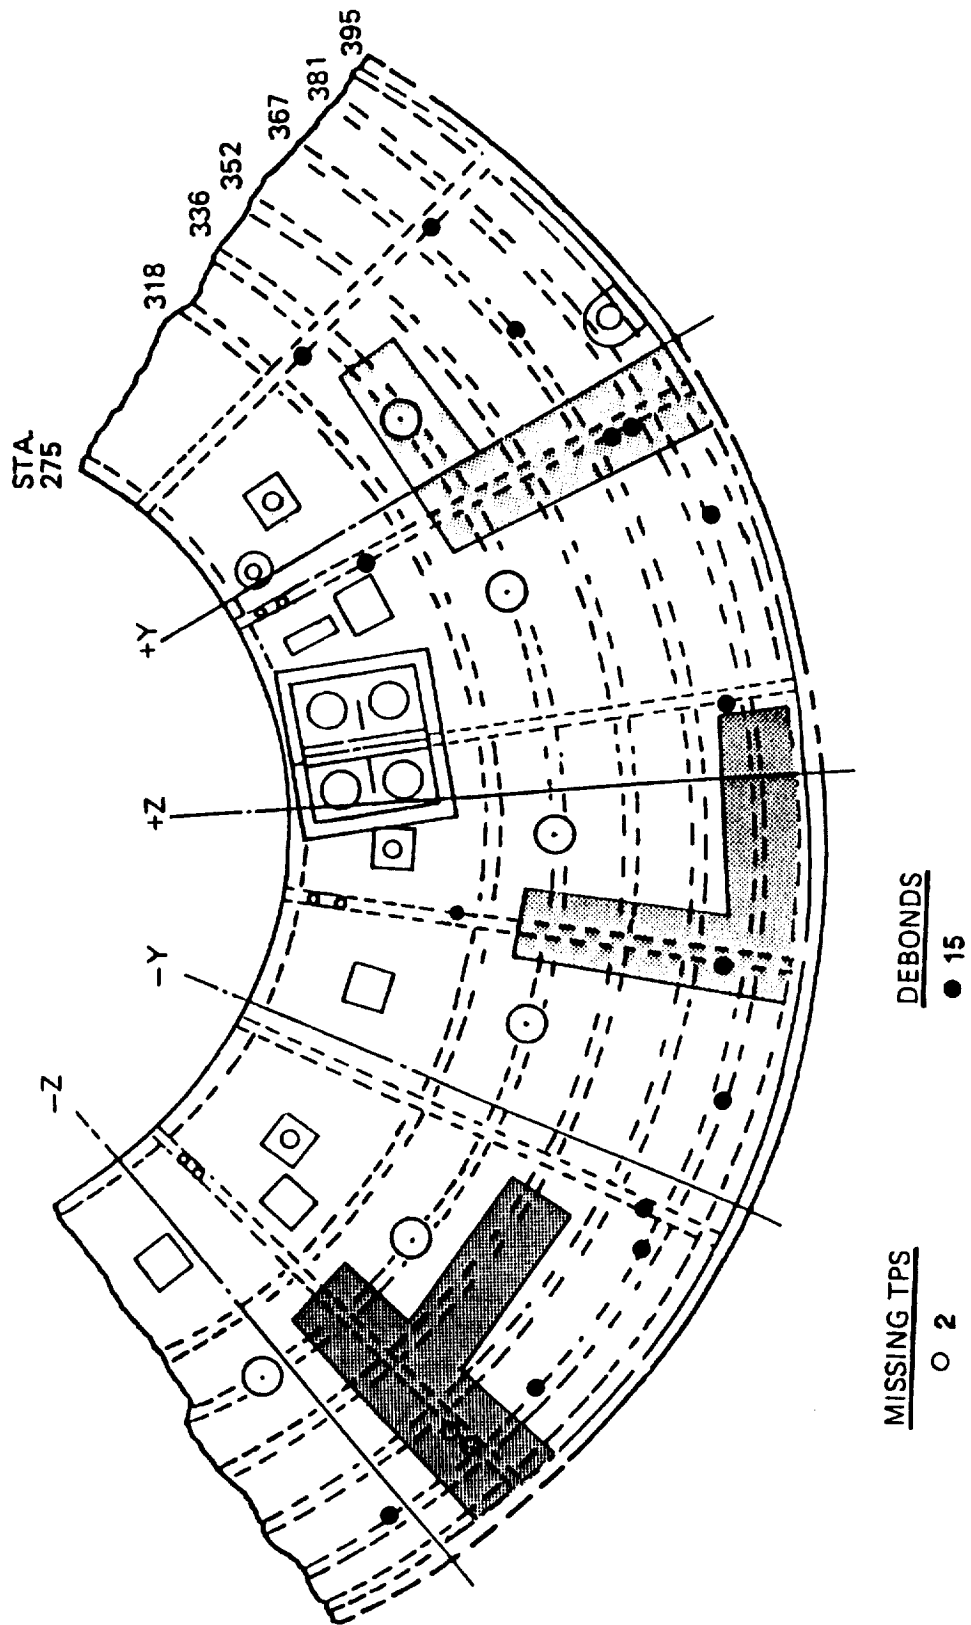
Figure 7. LEFT SRB FRUSTUM

The LH frustum had 15 MSA-2 debonds over fasteners and was missing MSA-2 (2.5"x1.5" maximum) from one location near the -Z axis. There was minor localized blistering of the Hypalon paint (Figure 7). The BSM aero heatshield covers were locked in the fully opened position. However, two RH cover attach rings had been bent at the hinge by parachute riser entanglement.

The LH frustum had 15 MSA-2 debonds over fasteners and was missing MSA-2 from one location near the -Z axis. There was minor localized blistering of the Hypalon paint. The BSM aero heat shield covers were locked in the fully opened position, but the two RH cover attach rings had been bent at the hinge by parachute riser entanglement.

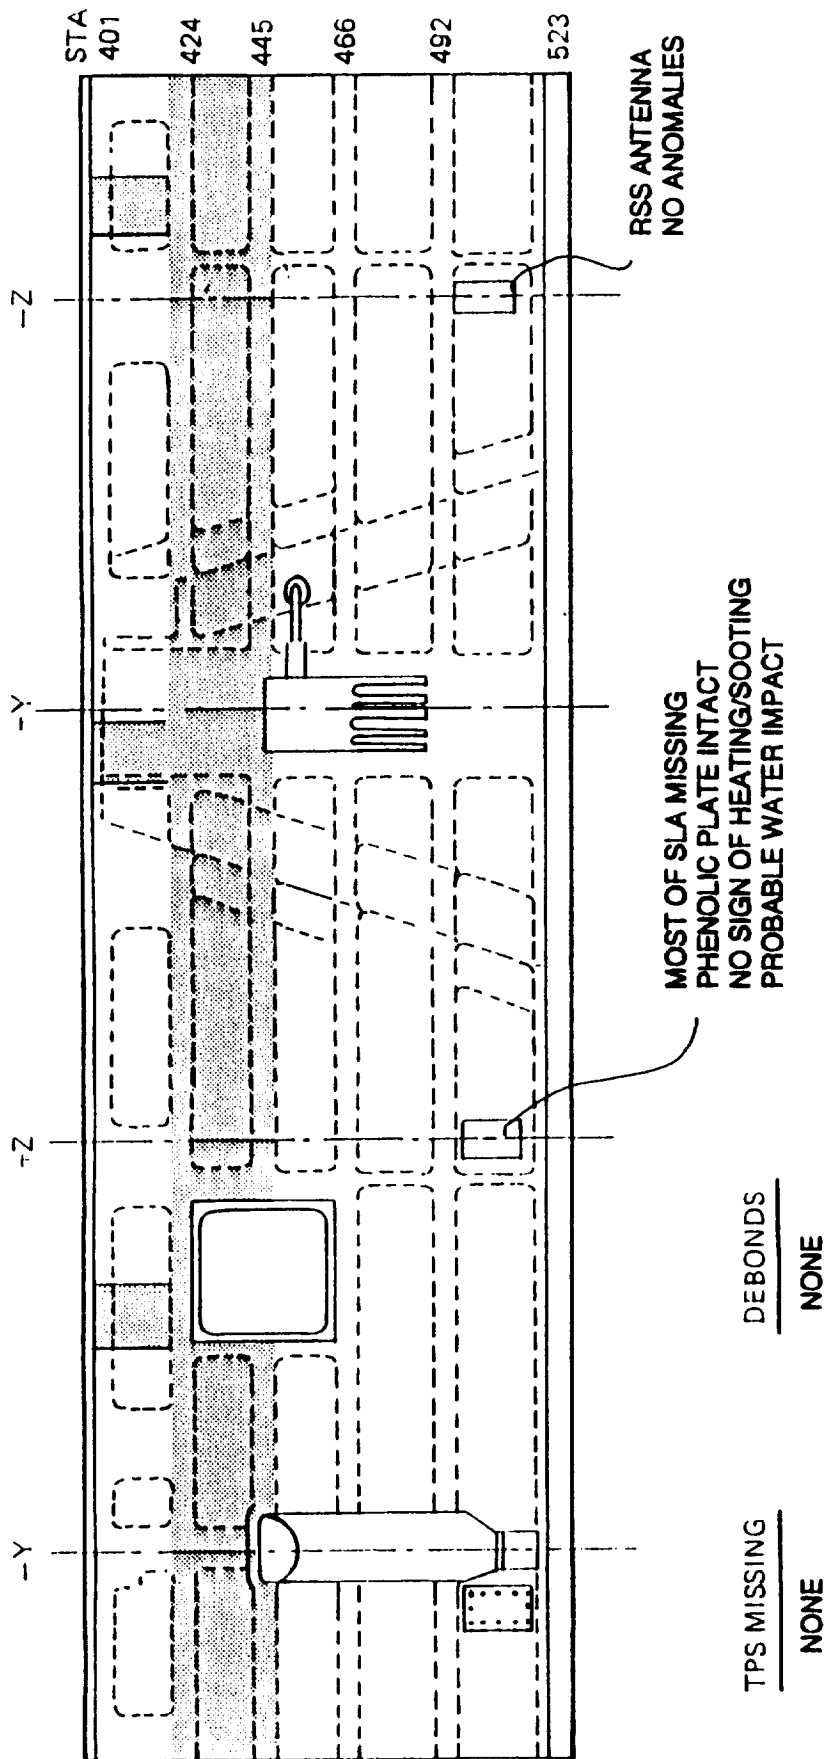
Figure 8. LEFT SRB FWD SKIRT

The LH forward skirt exhibited no debonds or missing TPS. The phenolic plates on both RSS antennae were intact. However, most of the ablator on the +Z antenna cover was lost at water impact (clean substrate) and was not a debris concern (Figure 8). The forward separation bolt and electrical cables appeared to have separated cleanly. No pins were missing from the frustum severance ring. Minor blistering of the Hypalon paint occurred near the ET/SRB attach point and on the systems tunnel cover.

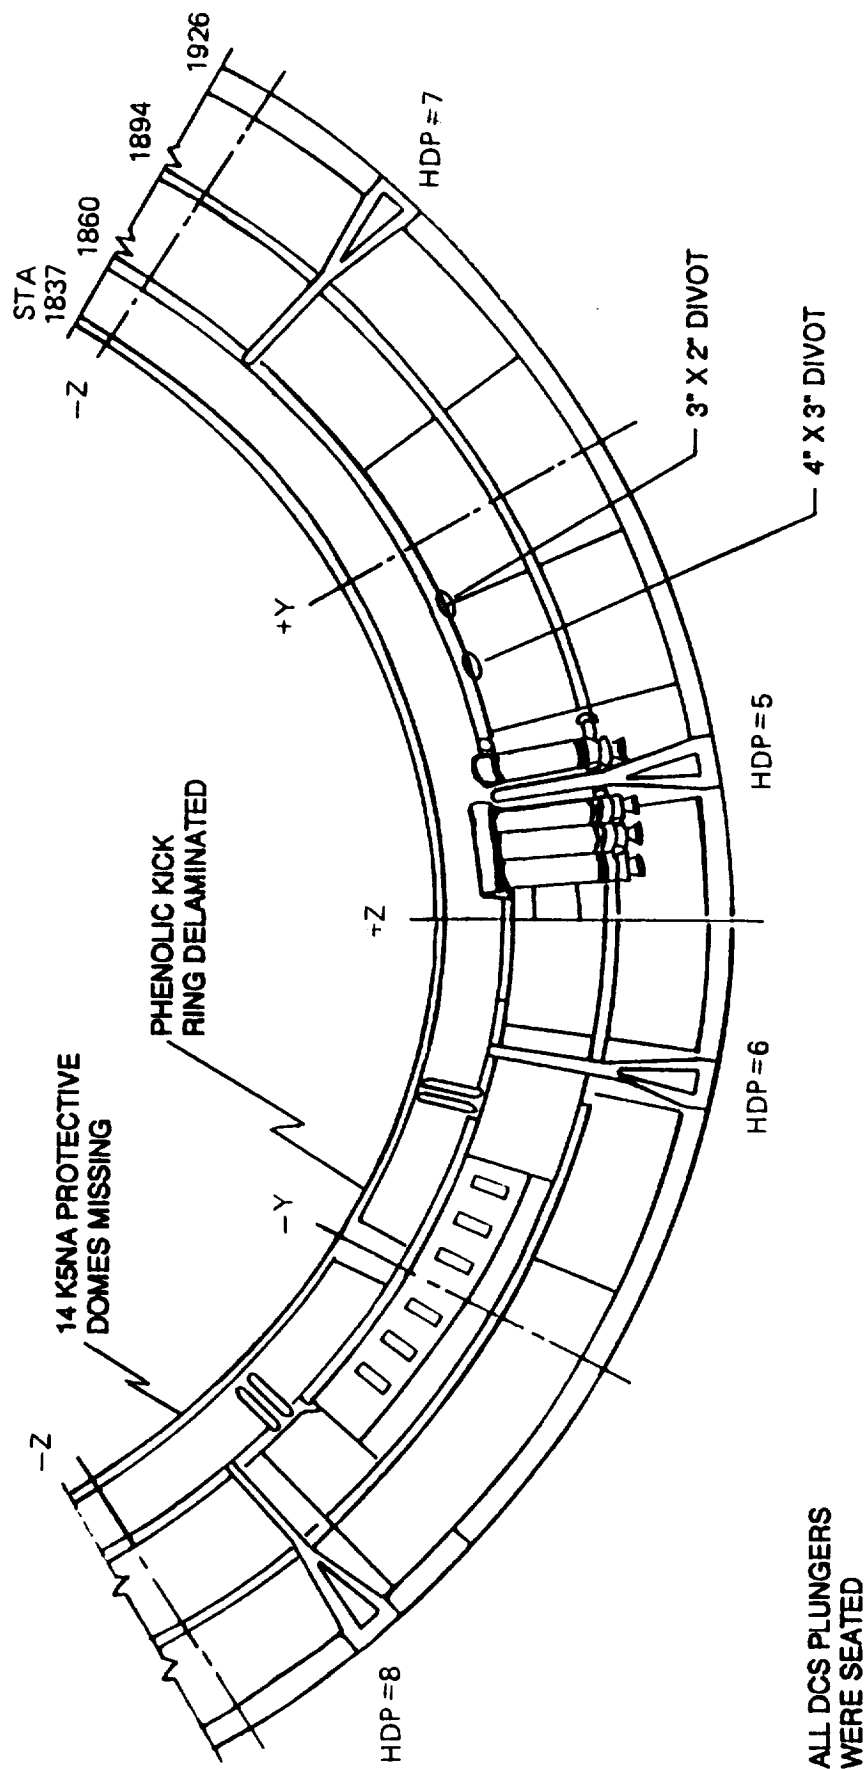
Figure 9. LEFT SRB AFT SKIRT EXTERIOR TPS

The phenolic material on the kick ring had delaminated. Some K5NA protective domes were missing from bolt heads on the aft side of the phenolic kick ring prior to water impact (charred substrate). The aft skirt acreage TPS was generally in good condition with the exception of two divots measuring 4"x3" and 3"x2" located between the single BSM and the +Y axis at XB-1860. Sooting pattern showed time of occurrence to be descent. K5NA was missing from all aft BSM nozzles (Figure 9).

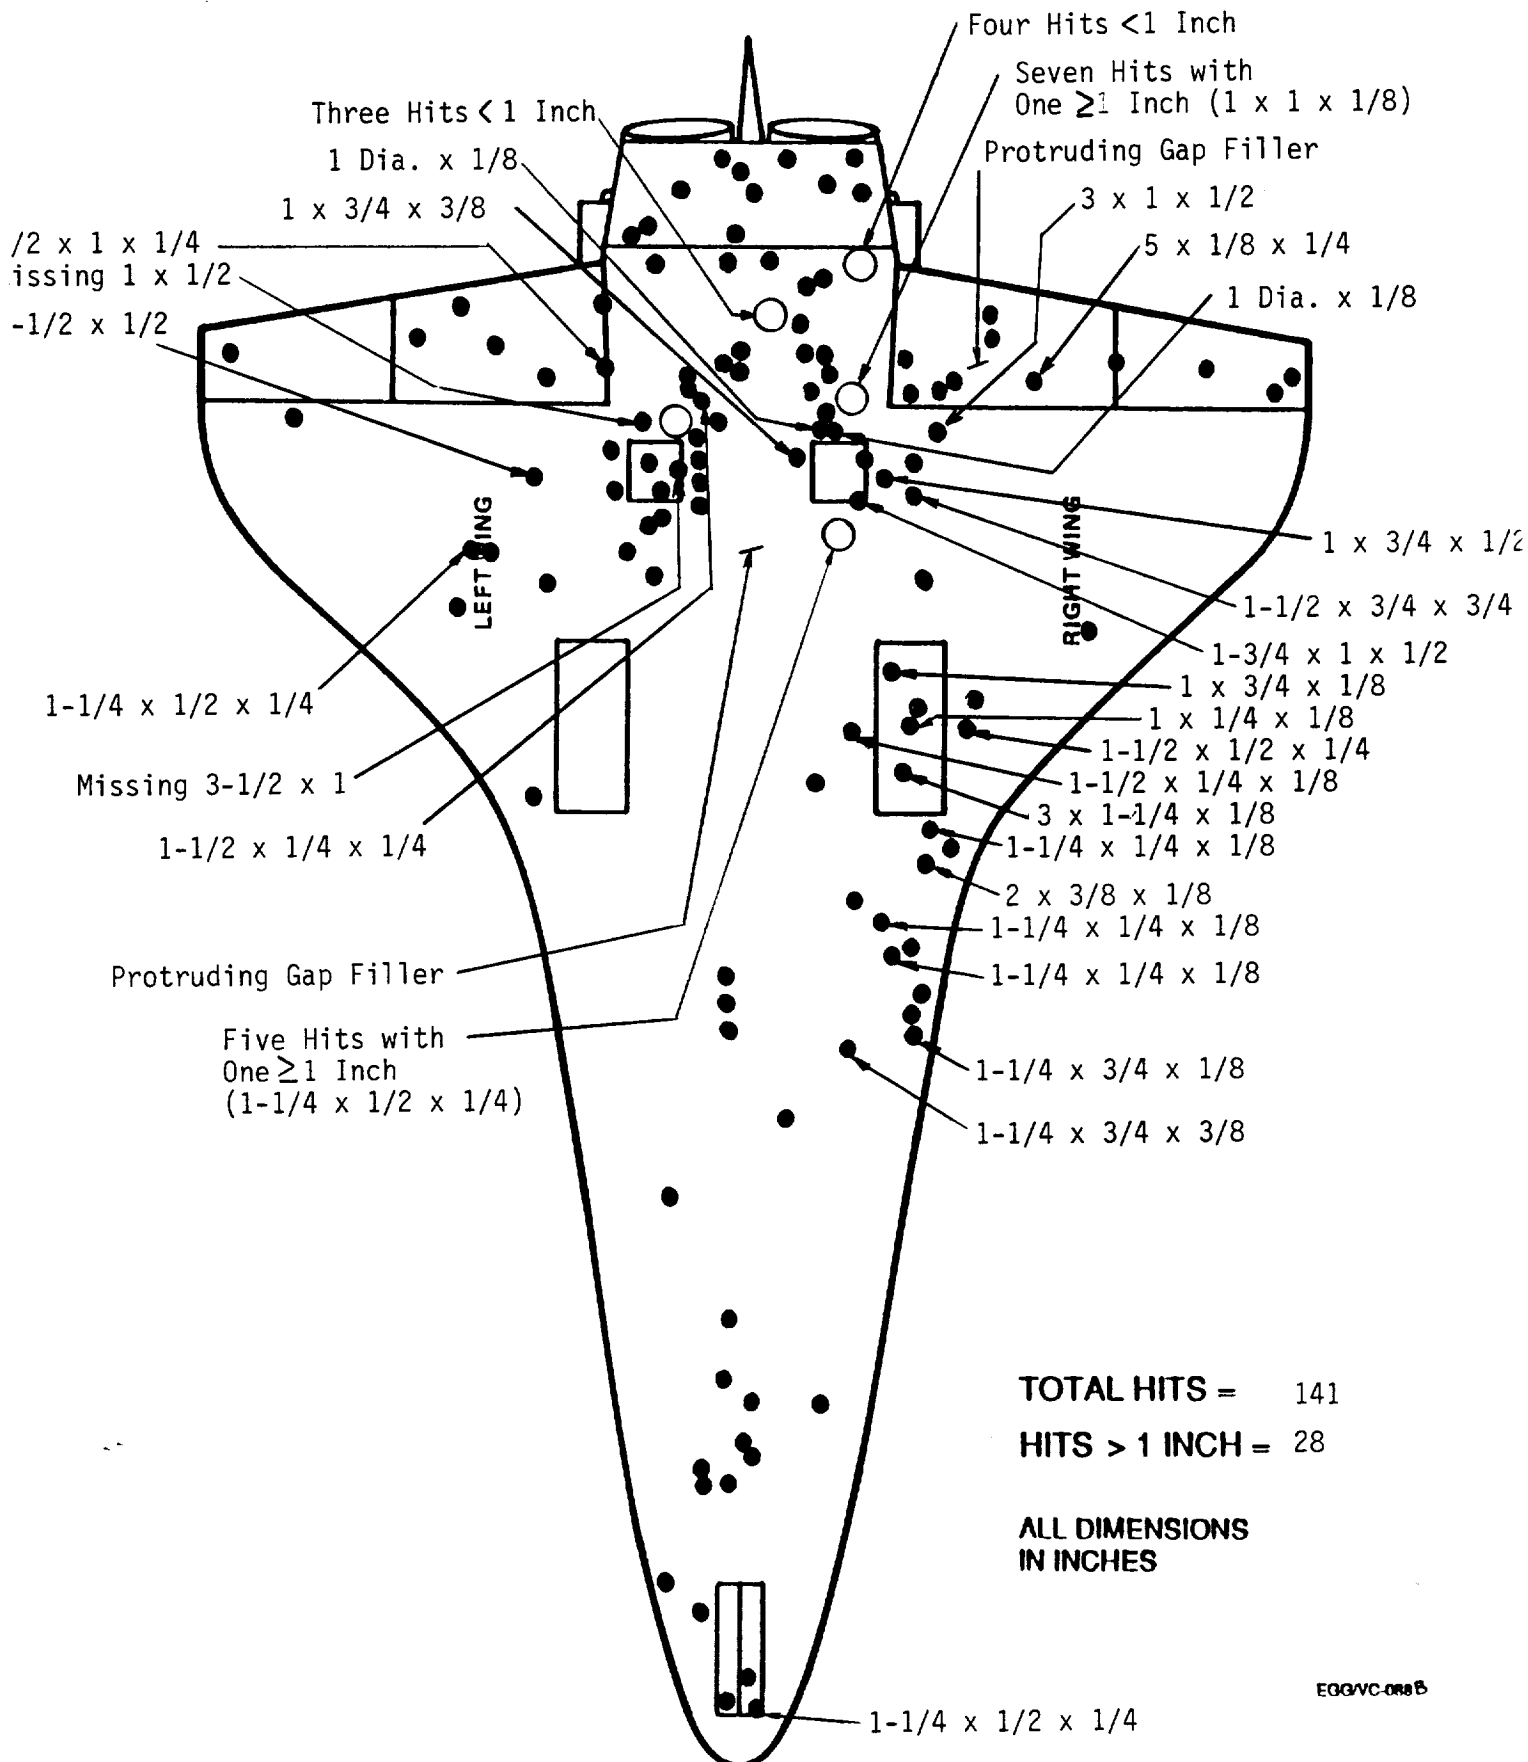
Figure 10. **DEBRIS DAMAGE LOCATIONS**

A detailed post landing inspection of OV-102 (Columbia) was conducted on 9 July 1992 (10th landing at KSC). The Orbiter TPS sustained a total of 184 hits, of which 45 had a major dimension of one inch or greater. The Orbiter lower surface had a total of 141 hits, of which 28 had a major dimension of one inch or greater. Based on these numbers and comparison to statistics from previous missions of similar configuration, the total number of Orbiter TPS debris hits was greater than average and the number of hits one inch or larger was much higher than average. The most significant tile damage measured 9.0" x 4.5" x 0.5", spanned three tiles, and was located approximately 3 feet outboard of the LH2 ET/ORB umbilical.

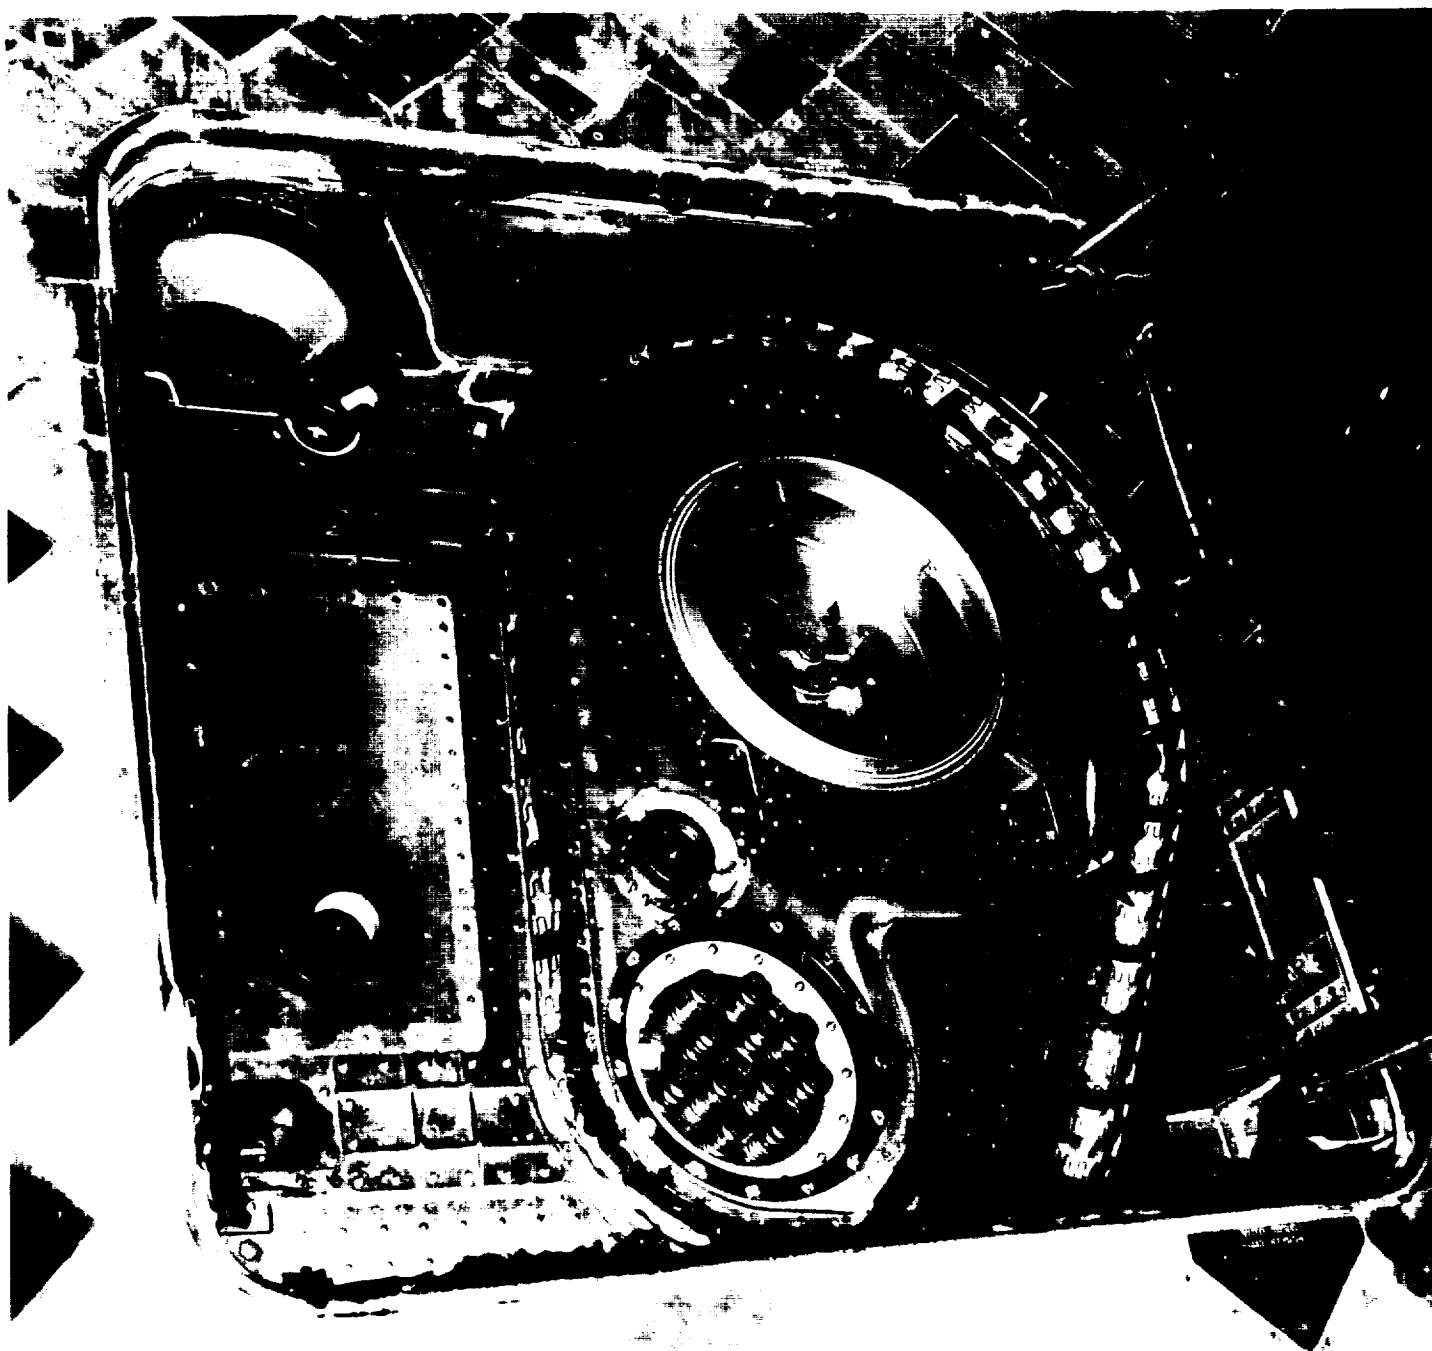
An expended detonator/electrical connector from the umbilical separation system fell to the runway when the RH (LO2) ET/ORB umbilical door was opened.

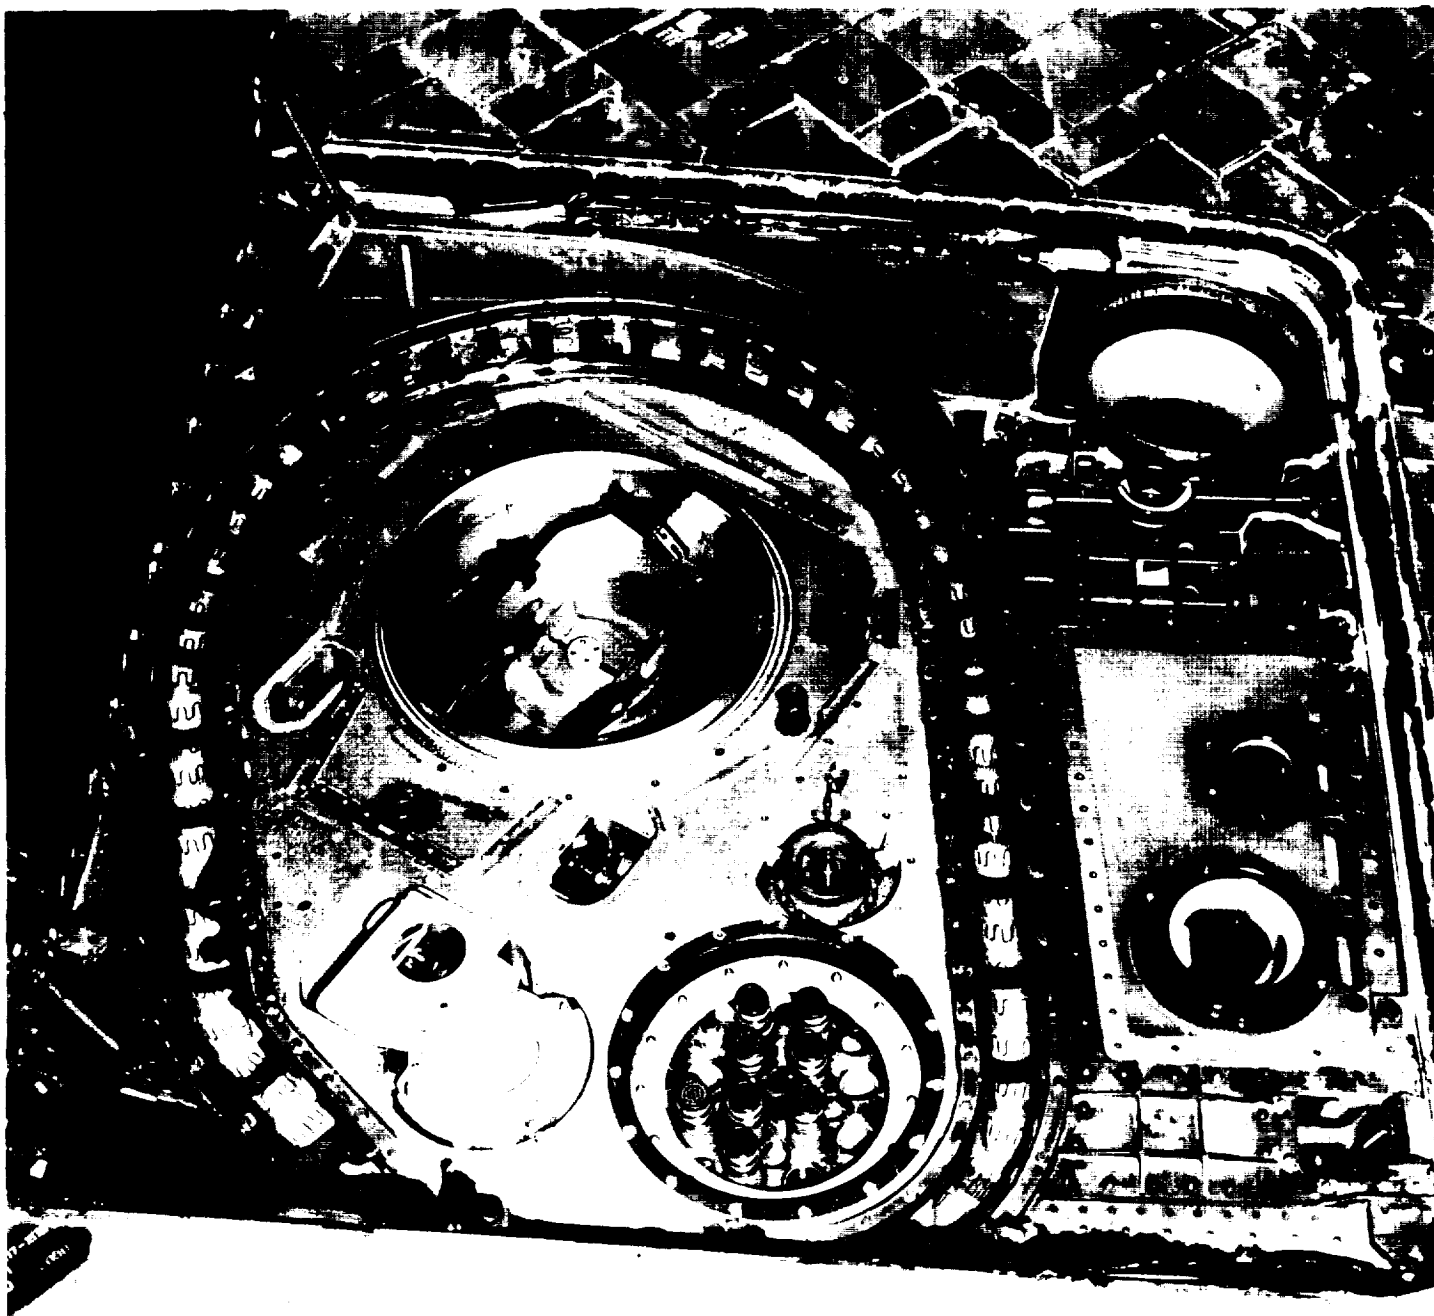
Overall view of the LO2 ET/ORB umbilical. All separation ordnance devices appeared to have functioned properly.

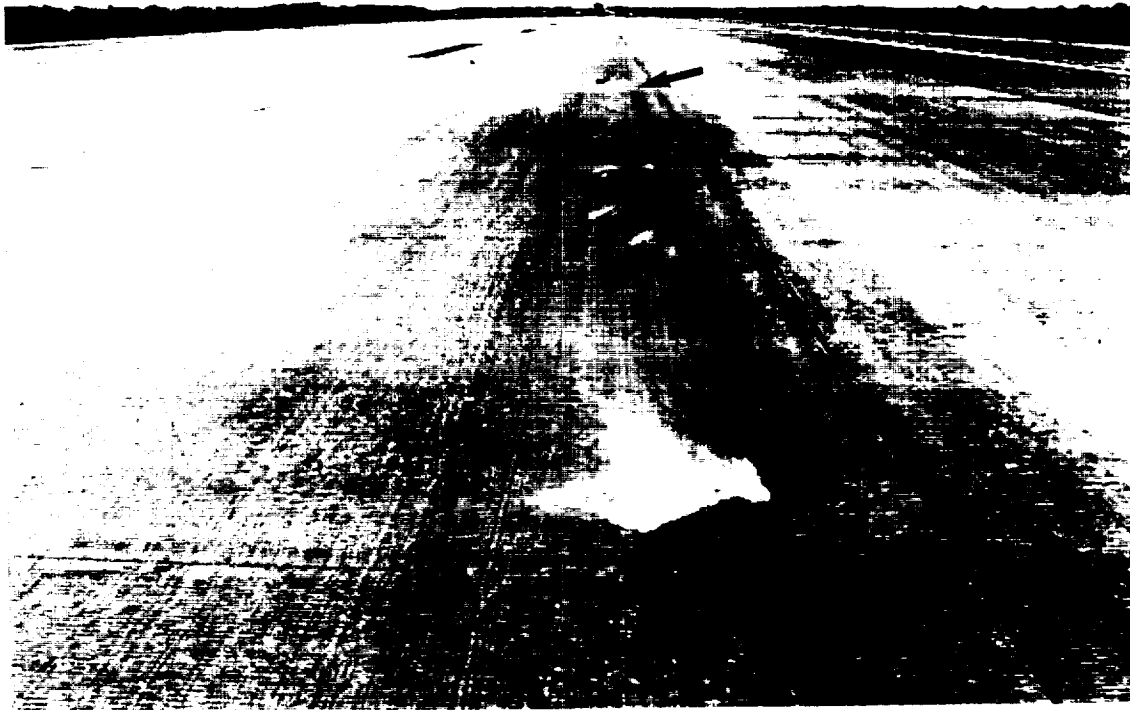
Figure 2.7.5 Drag Chute Door Runway Strikes

The arrows in Figure 2.7.5 shows the marks left on the runway by the drag chute door after chute initiation. The marks are to the right of the centerline as expected. This is different than the position of the door for STS-49 which went to the left of the centerline. The KSC report of the runway location of the drag chute assembly is located in Appendix D Task #10. Other debris found on the runway was an expended detonator/electrical connector (2 pieces) from the umbilical separation system.

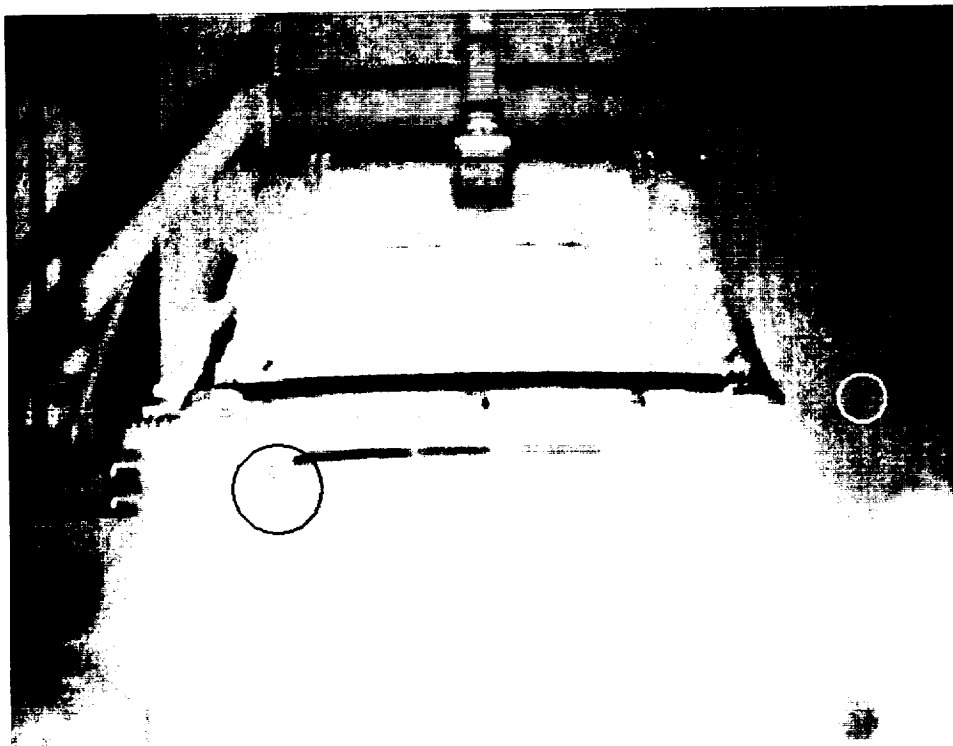
Figure 2

Figure two is a frame of film taken from camera E-52 showing a piece of loose thermal curtain tape on the right hand SRB.

Loose Thermal Curtain Tape
